INSPECTION REPORT

Report Number
5051

**123 Pebble Stone
Bedrock, Stone Age
62025**

Inspected by:
Mark Gum IL Lic # 450.0000112

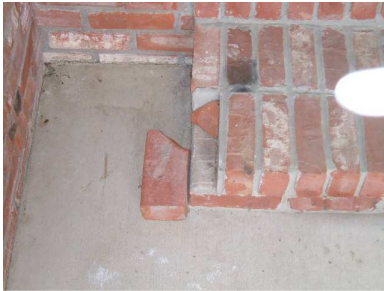
- 1 **CONDITION:** Exterior masonry brick is loose on the front porch step.
OBSERVED AT LOCATION(s): Front Porch Step
EXPLANATION & IMPACT: *Loose bricks are noted, May be a trip concern. Loose or missing bricks can allow moisture to enter the wall cavity causing damage to the structure and interior walls.*
RECOMMENDED ACTION: Repair

LOCATION: Front Porch Step

CONDITION: Exterior masonry brick is loose on the front porch step.

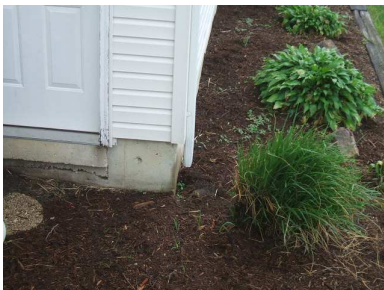
6

EXPLANATION & IMPACT: *Concentrated water discharge from the roof is occurring due to downspouts terminating near the home's foundation. This will promote water saturation of soils at the foundation and footings, and may result in moisture-related problems in the basement. Downspouts should be installed such that drainage will occur away from the foundation of the home. If possible, the discharge point from downspouts should be at least 6' (2m) away from the foundation. Water accumulation near the foundation may lead to foundation and basement dampness issues. This condition should be closely monitored; where basement dampness or foundation cracks are noted, remedial action is recommended to improve the grade and assure effective drainage will occur.*

LOCATION: Left rear corner

CONDITION: Downspout(s) discharge near foundation

RECOMMENDED ACTION: Review

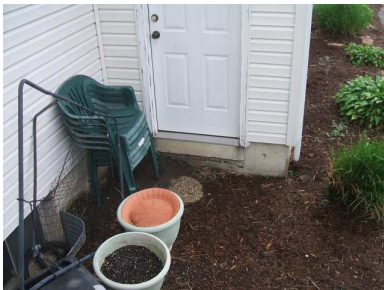
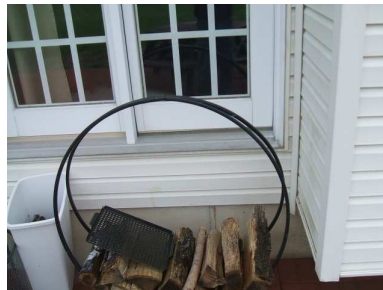
7

EXPLANATION & IMPACT: *Stairs are noted to be missing. Stairs should have a rise (height between steps) of about 8" (20 cm) and a run (depth of the treads) of about 9-10" (23-25 cm) to make the stairs easy to mount. Trips and falls are more likely to occur on stairs where there is an uneven rise or run. When using stairs, the tendency is to assume an even rise, and therefore tripping occurs either by over-stepping or under-stepping when mounting individual steps that have a rise other than expected. Stairs that have too shallow of a run present a higher risk of slips and falls by not being able to assure full foot contact on the tread. Unless corrected, stairs with these conditions present a greater risk of injury.*

LOCATION: Right rear living room door and the rear outside garage door

CONDITION: Exterior stairs are missing

RECOMMENDED ACTION: Install

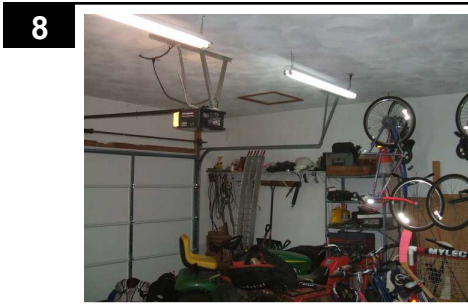
LOCATION: Right attic access in the Garage
CONDITION: The attic access hatch was blocked by personal items and storage
EXPLANATION: The access to the attic was blocked. This section of the attic could not be inspected.
IMPACT/CONSEQUENCES: The attic was not inspected in this area.
RECOMMENDED ACTION: Review

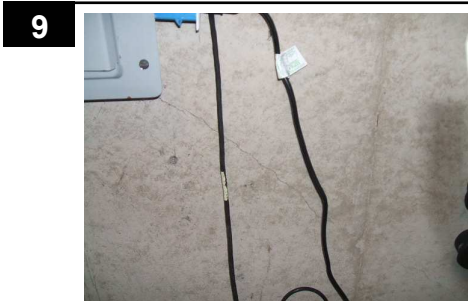
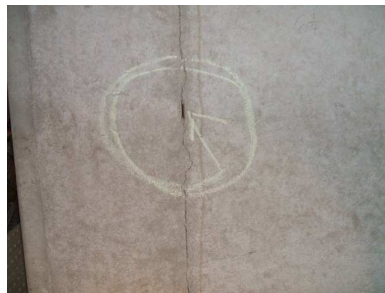
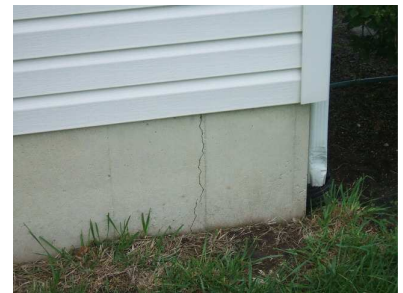
- 2 **CONDITION:** Foundation wall is cracked; minor
OBSERVED AT LOCATION(s): Right basement wall by the main electrical panel, front basement wall by the water line, right rear corner as seen outside
EXPLANATION & IMPACT: *Cracks in the foundation wall are observed during examination of the exterior of the home. At the time of inspection, the crack(s) are regarded to be minor. Ascertaining the cause of a crack cannot be readily determined during a home inspection, but are typically due to shrinkage of the concrete during curing, settlement of soils below the footings, pressure of soils against the foundation wall, or from a physical shock, seismic or hydrological event. At the time of inspection, adverse effects are not observed. Minor cracks should be monitored for change over time. Cracks that change in size and extent over time are an indication of settlement and should be reviewed by a foundation specialist, and may require further evaluation by a soils and/or structural engineer. Periodic monitoring is recommended to ascertain whether adverse effects are occurring. Note that a home inspection cannot predict whether an adverse consequence is likely to occur. For example, a crack that shows no indication of current or past evidence of water leakage to the interior may leak in the future.*

LOCATION: Right basement wall by the main electrical panel, front basement wall by the water line, right rear corner as seen outside

CONDITION: Foundation wall is cracked; minor

RECOMMENDED ACTION: Repair

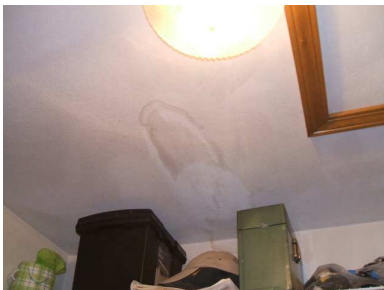
**LOCATION:** Master Bedroom Closet**CONDITION:** Water stains visible on interior ceiling surfaces**EXPLANATION:** Water stains are noted on the interior ceiling surface. This condition may be due to a specific event, or may be a condition that is likely to occur again in the future.**IMPACT/CONSEQUENCES:** The cause of the water stain should be investigated to determine whether the condition is due to a specific event that is likely not occur again in the future, or whether the condition is due to circumstances that carry the risk of reoccurring again in the future. The relative risk of this observation can only be properly assessed when the causes of the water staining are fully understood. The immediate action should be to investigate/query for cause of the water staining; further action may be required based on understanding the cause and the need for repair.**RECOMMENDED ACTION:** Review**14 LOCATION:** Basement furnace**CONDITION:** Electronic air filter is inoperative**EXPLANATION:** The electronic air filter is observed to be inoperative at the time of inspection.**IMPACT/CONSEQUENCES:** The electronic air filter may not be achieving its intended function. An electronic air filter that is not operating will not be filtering small particles from the air passing through the filter.**RECOMMENDED ACTION:** Review

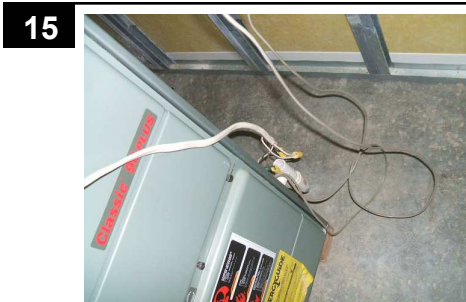
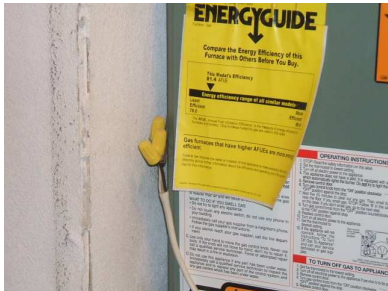
LOCATION: 2nd floor and basement furnaces

CONDITION: Furnace electrical disconnect switch was not found. There is a exposed splice at both furnaces power connections.

IMPACT/CONSEQUENCES: A disconnect switch for the furnace should be provided for safety. A furnace technician or electrical contractor should be consulted to assure the means of electrical disconnect meets current safety standards for installations.

RECOMMENDED ACTION: Install

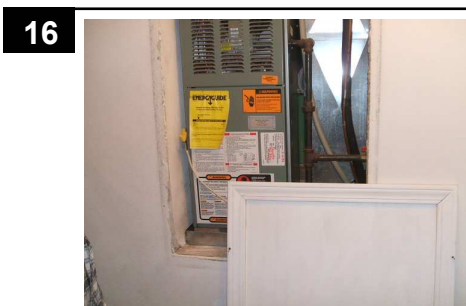
LOCATION: 2nd floor furnace closet

CONDITION: Insufficient supply air

RECOMMENDED ACTION: Adjust

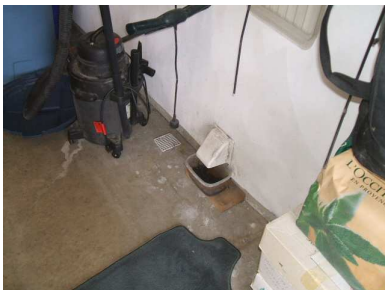
18

**LOCATION:** Garage**CONDITION:** Dryer vent does not terminate outside.**EXPLANATION:** The vent for the dryer is not installed to the exterior of the building.**IMPACT/CONSEQUENCES:** Dryer vents should be exhausted to the outside of the building. It is recommended that dryers do not vent into the crawl space under the building.

or in the garage. This can add moisture to the underside and interior of the structure as well as lint residue.

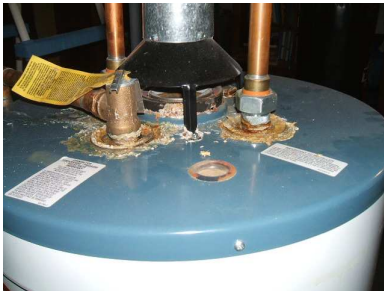
22

**LOCATION:** Basement**CONDITION:** Water heater is leaking at the water line and the TPR valve on top of the water heater**EXPLANATION:** Water leakage of any amount is an indicator of current or developing problems with the water tank. Old water tanks generally rust at the bottom, and minor leaks from perforation are a precursor to ultimate rupture failure of the tank.**IMPACT/CONSEQUENCES:** Leaks of any degree require immediate investigation and corrective action. Damaged or old tanks displaying water leakage will likely require replacement.**RECOMMENDED ACTION:** Replace

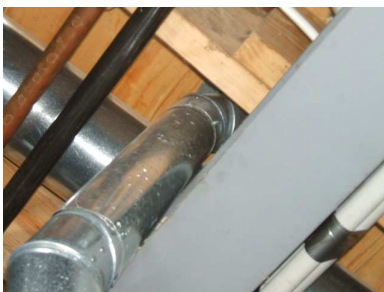
23

**LOCATION:** Water Heater**CONDITION:** Insufficient clearance of exhaust flue from combustibles**EXPLANATION:** Combustible materials are noted to be in close proximity to the exhaust flue for the water heater.**IMPACT/CONSEQUENCES:** To reduce the risk of fire, adequate clearances are required between the exhaust flue and combustible surfaces or materials. In the course of inspecting the heating system, the exhaust flue appears to be in close proximity to a permanent interior feature, presenting a potential risk of fire. Note that manufacturer's specifications for clearances may vary for various furnaces and installations, and the determination of safe clearances is generally performed by heating technicians. It is suggested that a certified heating specialist be consulted to review the installation for safety.**RECOMMENDED ACTION:** Consult Specialist

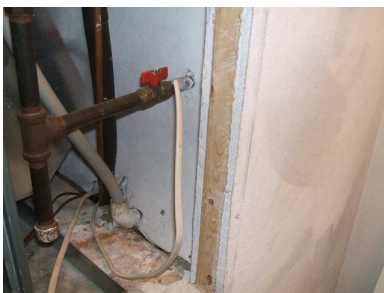
24

**LOCATION:** 2nd floor furnace closet**CONDITION:** Unterminated active wiring observed**EXPLANATION:** Wires are observed to be not terminated in a protective box, and this wiring is active.**IMPACT/CONSEQUENCES:** Active wiring should be properly terminated at a protective box, panel, or fixture. Exposed wire ends present the risks of electrical shock or fire. This condition is a safety concern and should be immediately rectified.**RECOMMENDED ACTION:** Repair

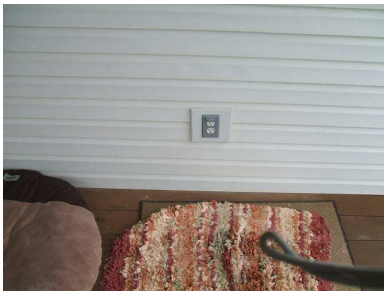
28

LOCATION: Exterior Back

CONDITION: An exterior outlet has a damaged receptacle cover
